Delaware Basin Operator Records 500 Days and Counting of Continuous Pump Run Time.

Customized BHA with 3D Screen Technology eliminates costly workover activity.

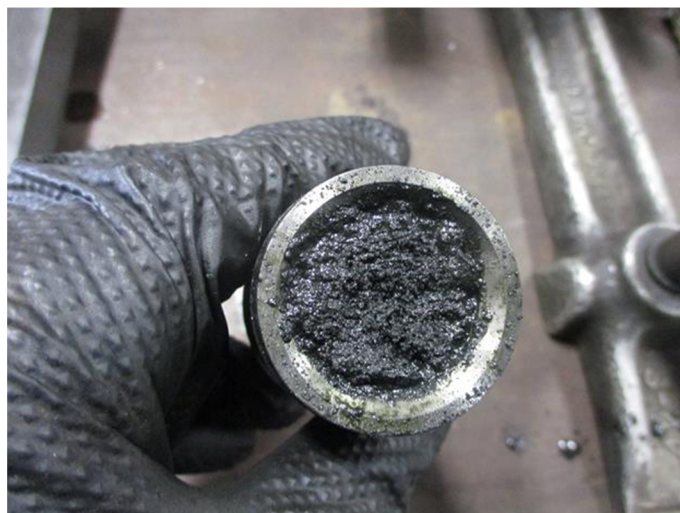
Image 1: Travel valve cage packed off with formation solids.

Following a fourth pump failure in four months, a major operator was forced to shut-in its Delaware Basin well. In each instance, the pump was packed off with sand. At the time of the 4th failure, a minimum of 20 non-production days was experienced and at least \$80,000 in workover costs. Sand and other solids increase wear in pumps and production equipment, adversely impacting equipment performance, increasing maintenance costs, and reducing or even shutting down production. Image 1 and Image 2 depict the damage to the pump.

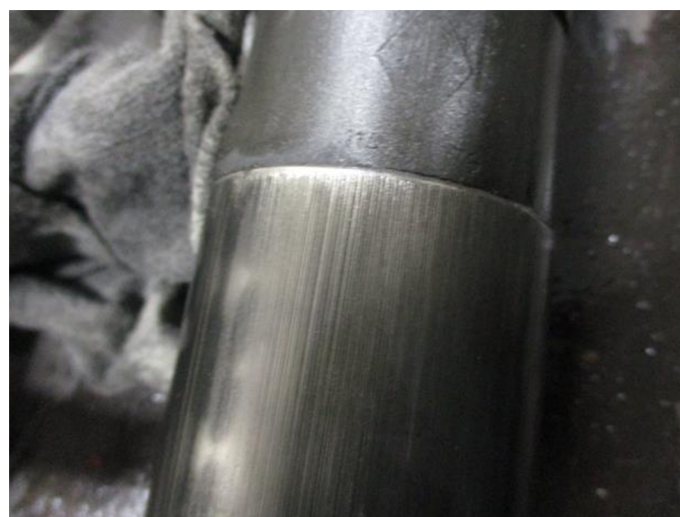
Image 2: Plunger spray metal grooved from formation solids.

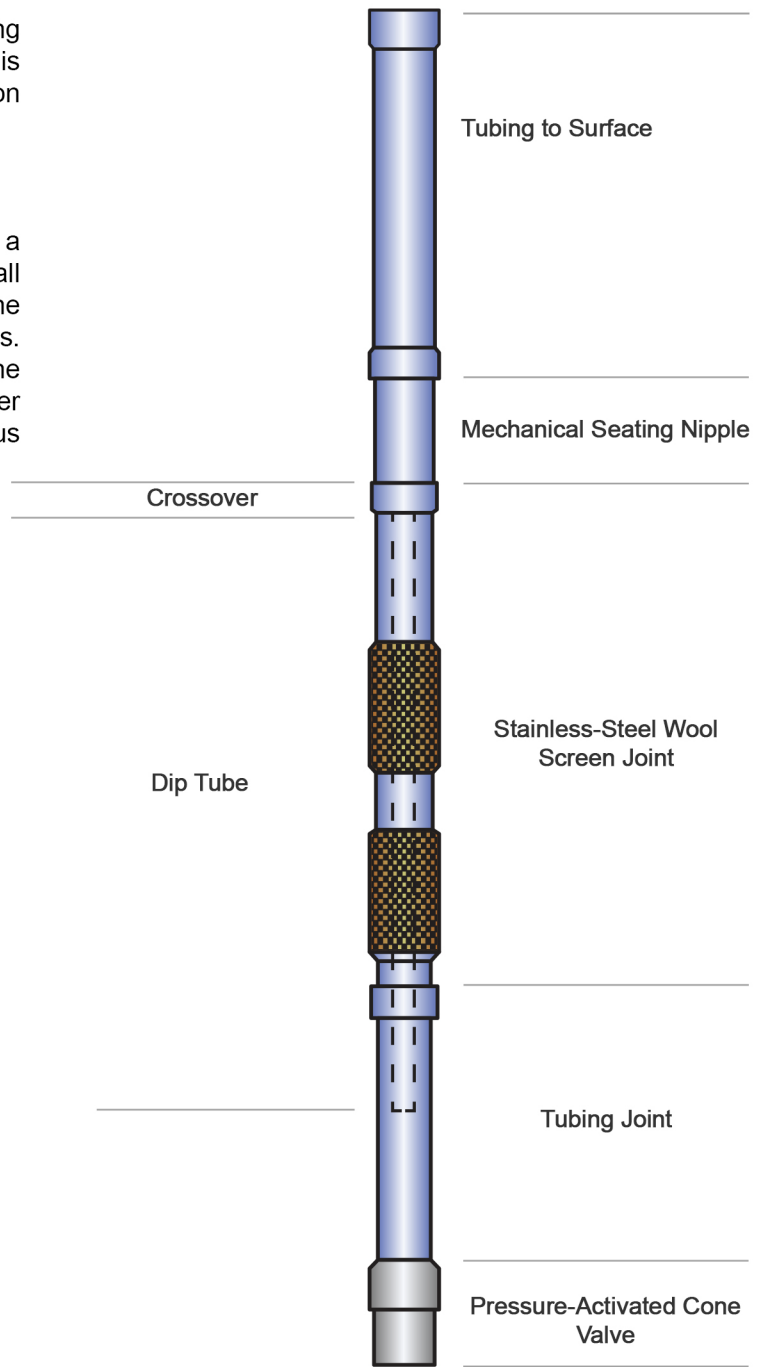
Figure 1: BHA Schematic with 3D Screen Technology.

Don-Nan's Solutions Team analyzed performance records in our PumpTrak™ system and consulted with the operator. The Solutions Team configured a customized bottom hole assembly (BHA) with 3D screen technology. The BHA comprised of a single 2 3/8-in. stainless steel-wool screen joint, in combination with a pressure activated cone valve assembly and a dip tube. Extending further below the fluid entry point, the dip tube would help keep gas out of the pump. The proposed solution addressed both sand and gas production and its adverse effects on pump performance. Refer to Figure 1 for the BHA Schematic with 3D Screen Technology.

The patented stainless steel-wool screen creates a unique 3D filtration system to keep a wide range of particle sizes from entering the pump. Using highly permeable compressed stainless-steel wool wrapped around a perforated base pipe and protected by a perforated shroud, the screen's non-uniform, angular pores are hard to plug, delivering an open flow area of 40 percent. The pore size diversity ranges from 15 to 600µm. The collection of larger particles around the screen creates an enhanced permeability zone with a higher flow capacity to yield greater productivity. The screens are robust and corrosion-resistant, providing structural strength and stability during deployment and production.

A pressure-activated cone valve was installed below the screens to extend the life of pumps and equipment. As sand bridges the annular space between the casing wall and screen, it chokes fluid flow through the tubing, increasing differential pressure between the tubing and annulus. When this pressure reaches a pre-set limit, the cone valve opens to allow flow to continue through the pump. With fluid once again flowing, the resulting changes in pressure and flow force the buildup of solids to fall away from the screen.
