Continual Fine Solids and Gas Handling Extends Pump Run Time to More Than 160 days

Optimal BHA Design with 3D Screen dramatically reduces sand-production and gas-interference issues. BHA installed without wellbore cleanout run.

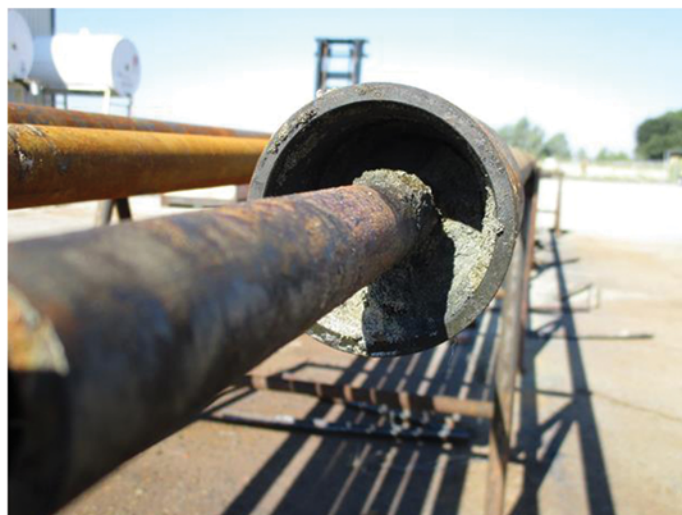
Image 1: SRP stuck in tubing due to solids

An operator in Eddy County, New Mexico began experiencing severe sanding problems shortly after installing a new pump. The mud joints completely filled and sand began producing through the pump, even with a desander included in the bottom hole assembly (BHA). The pump packed off after 18 days of run time. The operator found that the pump was stuck in the tubing, with sand filling the mud anchor joints completely and the two joints above the pump. The operator requested installation of the new BHA without a wellbore cleanout run, to avoid incurring additional downtime. Image 1 and Image 2 depict the damage to the pump.

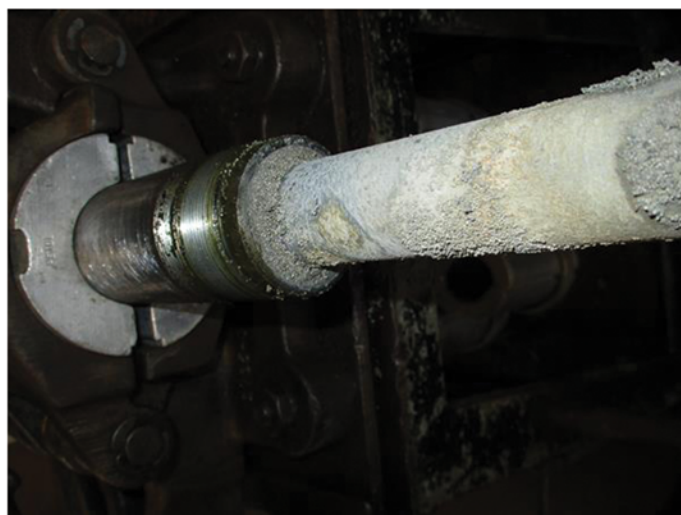
Image 2: SRP travel assembly stuck in standing assembly due to solids, observed during disassembly.

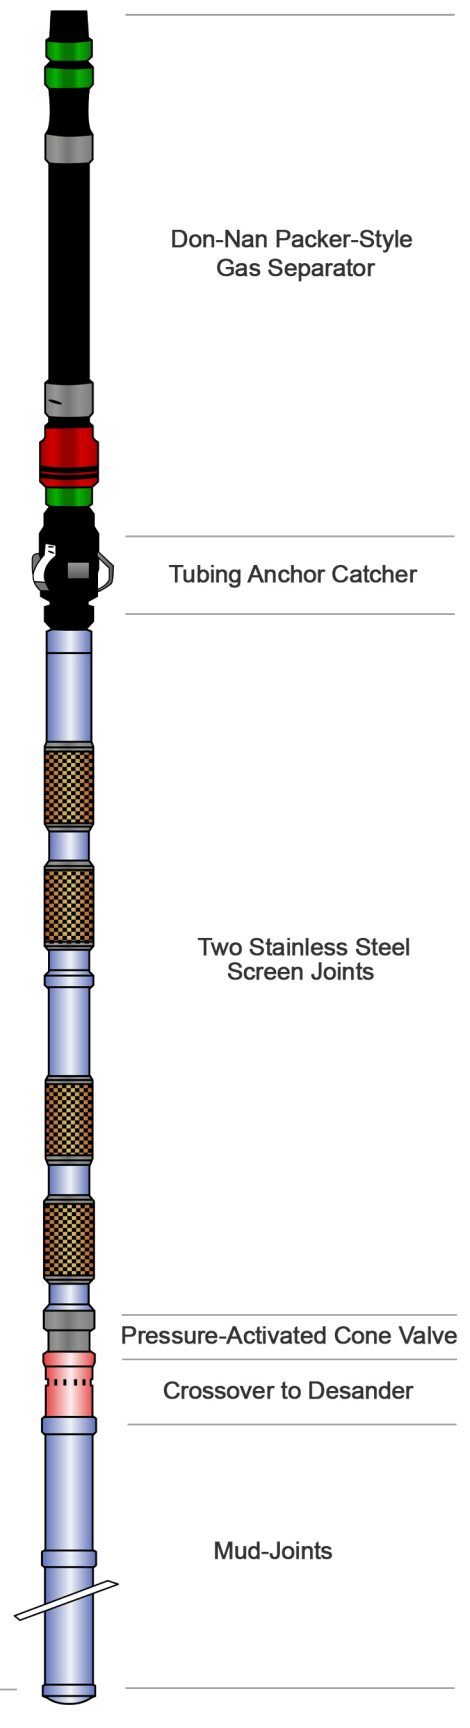
Figure 1: BHA Schematic with 3D Screen Technology

- A packer-style gas separator
- 3D screen technology - two 2-3/8 in. stainless steel-wool screen joints
- A pressure-activated cone valve
- A desander above two mud joints

Refer to Figure 1 for the BHA Schematic with 3D Screen Technology. The patented stainless steel-wool screen creates a unique 3D filtration system to keep a wide range of particle sizes from entering the pump. Using highly permeable compressed stainless-steel wool wrapped around a perforated base pipe and protected by a perforated shroud, the screen's non-uniform, angular pores are hard to plug, delivering an open flow area of 40 percent. The pore size diversity ranges from 15 to 600µm. The collection of larger particles around the screen creates an enhanced permeability zone with a higher flow capacity to yield greater

productivity. The screens are robust and corrosion-resistant, providing structural strength and stability during deployment and production. A pressure-activated cone valve inserted below the screens was installed to extend the life of pumps and equipment. As sand bridges the annular space between the casing wall and screen, it chokes fluid flow through the tubing, increasing differential pressure between the tubing and annulus. When this pressure reaches a pre-set limit, the cone valve opens to allow flow to continue through the pump. With fluid once again flowing, the resulting changes in pressure and flow force the buildup of solids to fall away from the screen. This reestablishes flow through the screens, dropping differential pressure, and closing the cone valve. This cyclic process repeats as needed, with no intervention required.

The desander was installed as a contingency measure to protect the pump when the cone valve is activated. When the valve opens, the desander prevents solids in the fluid from reaching the pump. It provides the added benefit of acting as a barrier to keep gas away from the cone valve when it is in closed position.
