## South Oman Success with Wear-Resistant Reciprocating Rod Pump

**New pump metallurgy suitable for harsh well conditions, reduces workover intervention costs and minimizes hidden deferment. Pilot success results in average cost savings of USD 130,000 per well**

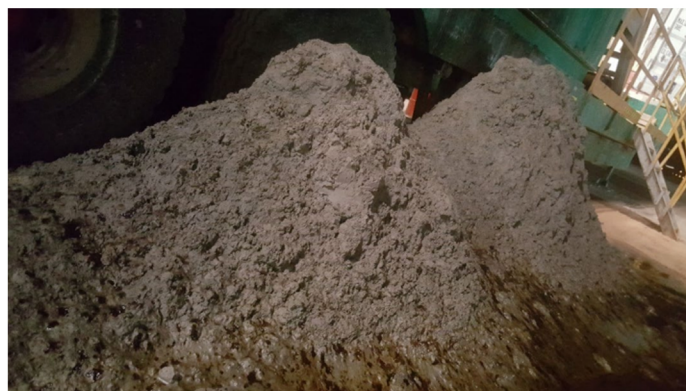
Image 1: Sand production from one well during cleanout.

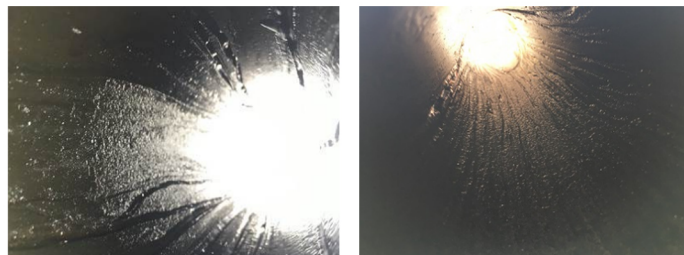
Image 2 (L), 3 (R): Old barrel with deep scoring and grooves on the inside.

In South Oman, an RRP was being used to produce up to 400-m<sup>3</sup>/d (2,500 B/D) oil wells in harsh well conditions and was experiencing a 75% pump failure rate with significant underperforming of the pump efficiency, called hidden deferment. Analysis showed that the overwhelming reason for the failure was the produced sands/solids, which were scratching and scoring the pump barrels and causing corrosion on the barrel base metal, leading to a combined erosion/corrosion failure mode.

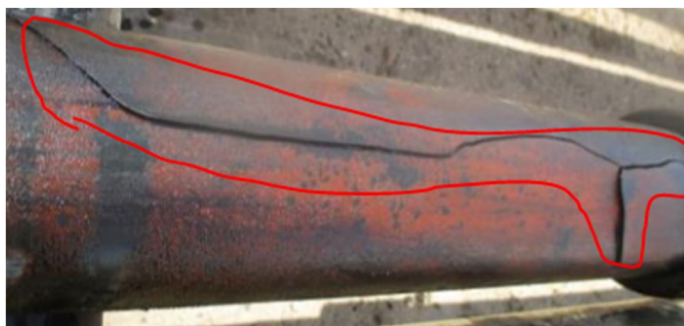
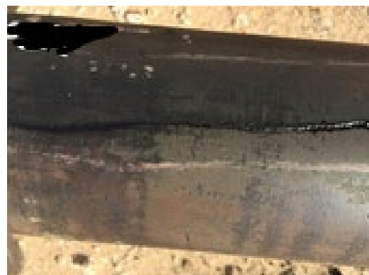
Image 4 (T), 5 (L): Old barrel with longitudinal crack caused by inside grooving.

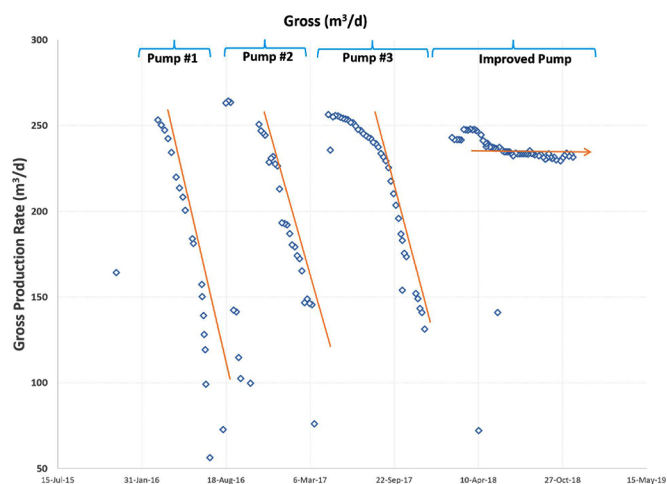
As depicted in Figures 1 and 2, the charts for Wells 1 and 2 each show three older pumps that start off with stable production, but then rapidly drop off in efficiency before failure, in a period of hidden deferment. The customer lost a great deal of oil production before they needed to replace the pump. By comparison, the improved trial pump shows stable production throughout its run life before failure, with no hidden deferment period—no production was lost.

Figure 1. Well 1 performance.

For tabulated results, see Table 1. In a single well, the older pump's run life was 244 days vs. 654 days for the new trial pump. This avoided about three well interventions to replace the pump. And with 80 days of hidden deferment (underperformance) with the older pump, the customer lost 30 BOPD multiplied by 80 days. Lost production plus rig downtime plus the repeated cost of replacement equipment equals a great deal of unnecessary expense. Our customer was so encouraged by the performance of the improved LUFKIN trial pump that they decided to expand its use on a larger scale.

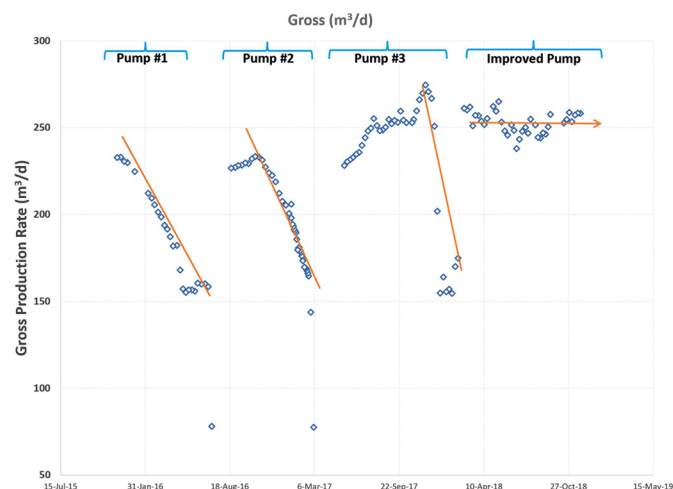
Figure 2. Well 2 performance.
